Terminal Block Wiring Gate

August 20, 2012

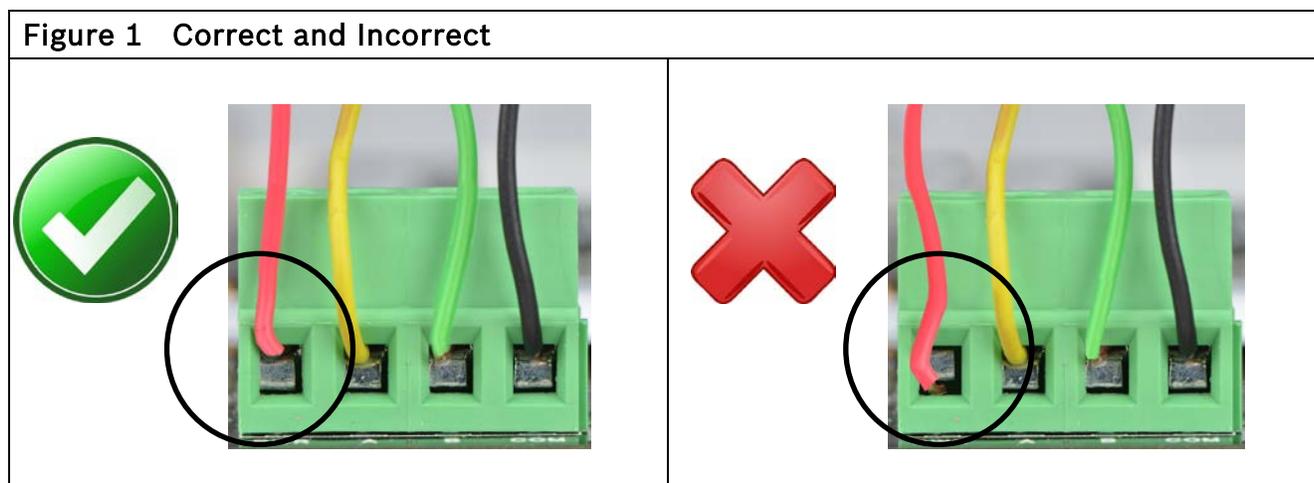
Incorrect insertion of the wire below the gate of the terminal block can cause a short on the board, overheating, and component failure. Based upon control panel programming, the device is reported as missing by the control panel.

Verify the wiring is inserted correctly into the terminal block gate to avoid the issue. Refer to *Figure 1* below.
